Narrow Band Ultrasonic Spectroscopy

N-BUS

Narrowband Resonance Spectroscopy

Detection of defects in new Low Density Carbon – Carbon composite material

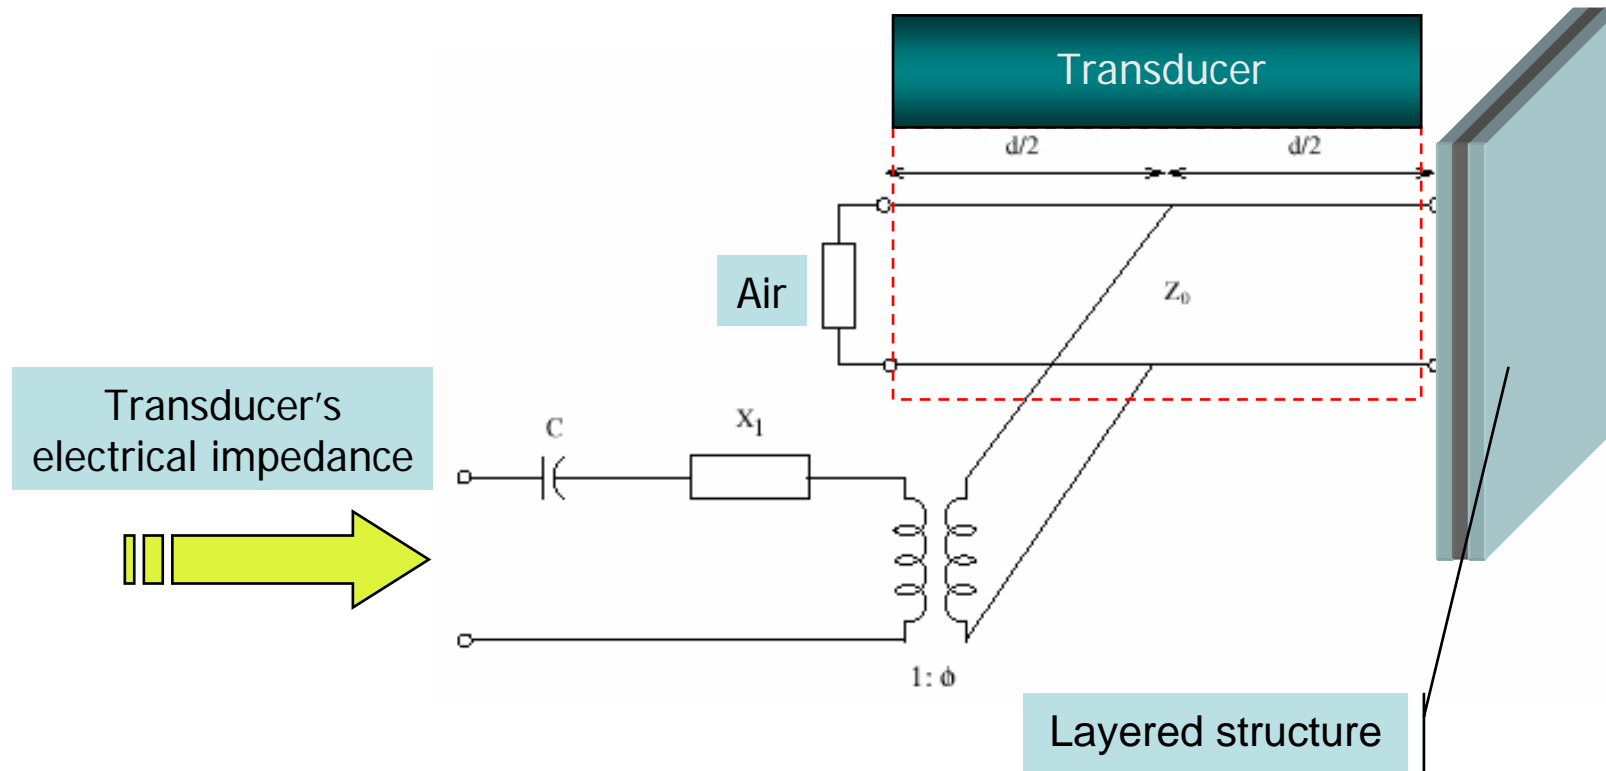
Narrowband spectroscopy of composite structures

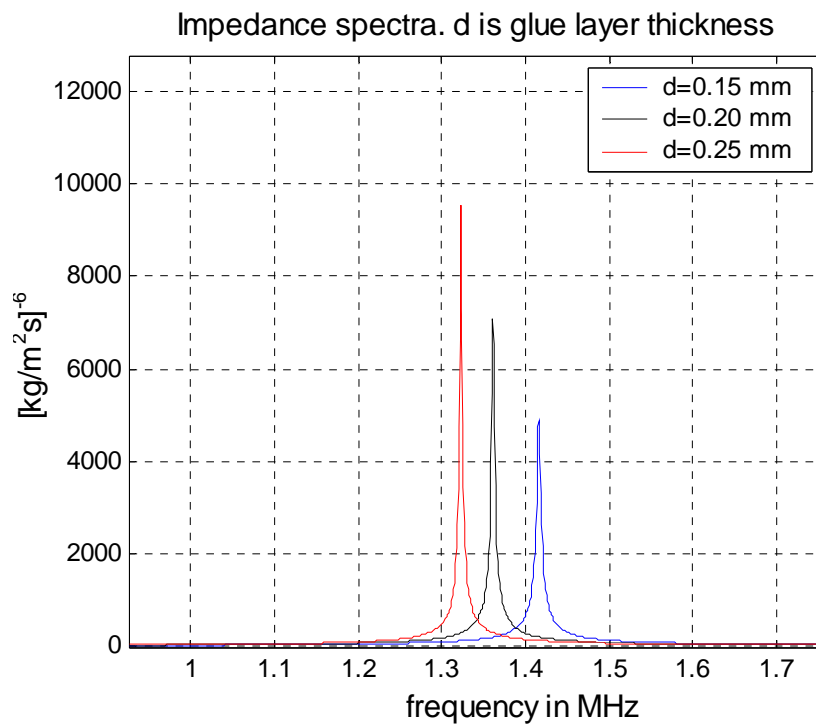
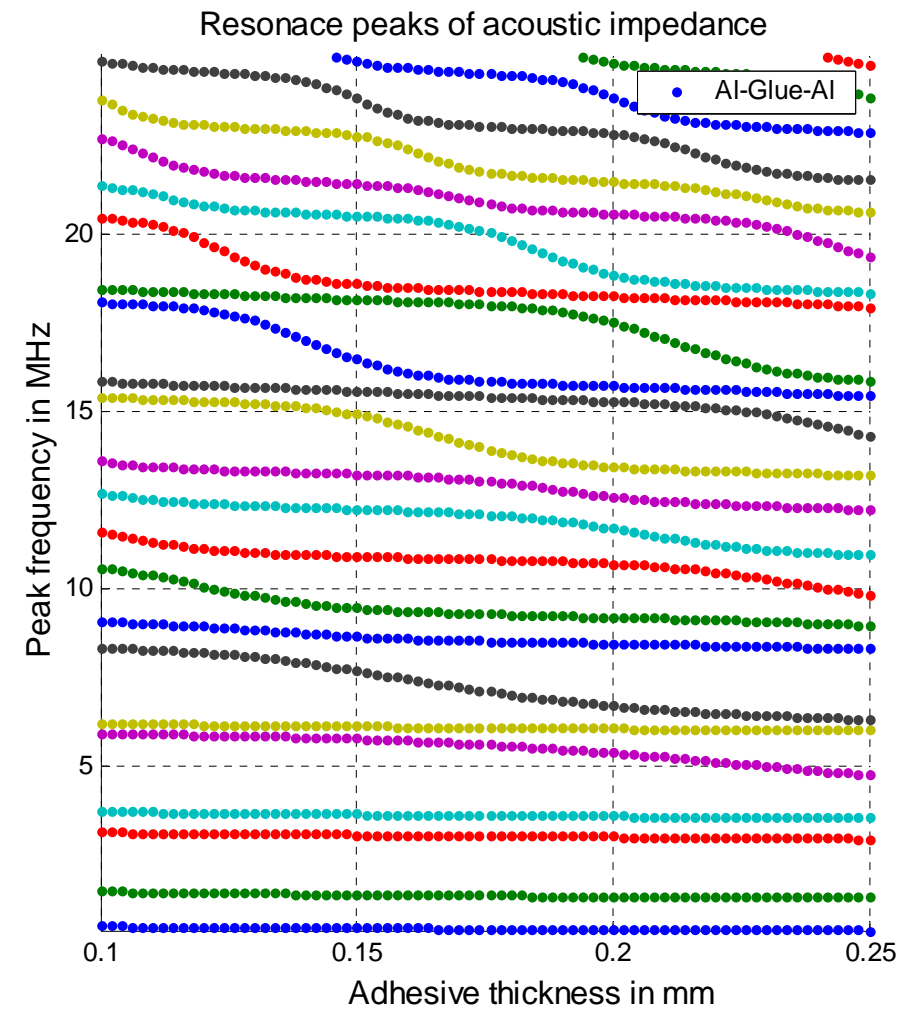
Influence of adhesive layer thickness

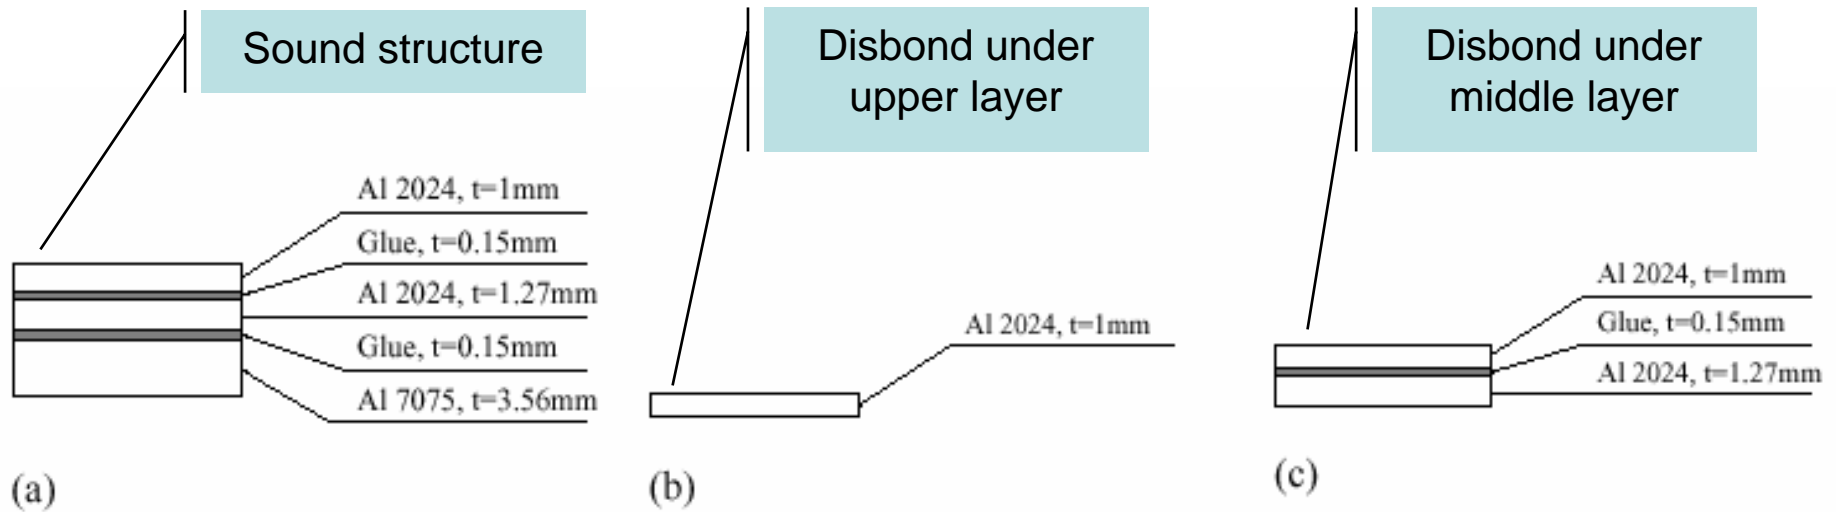
Impedance: three-layered Al structure

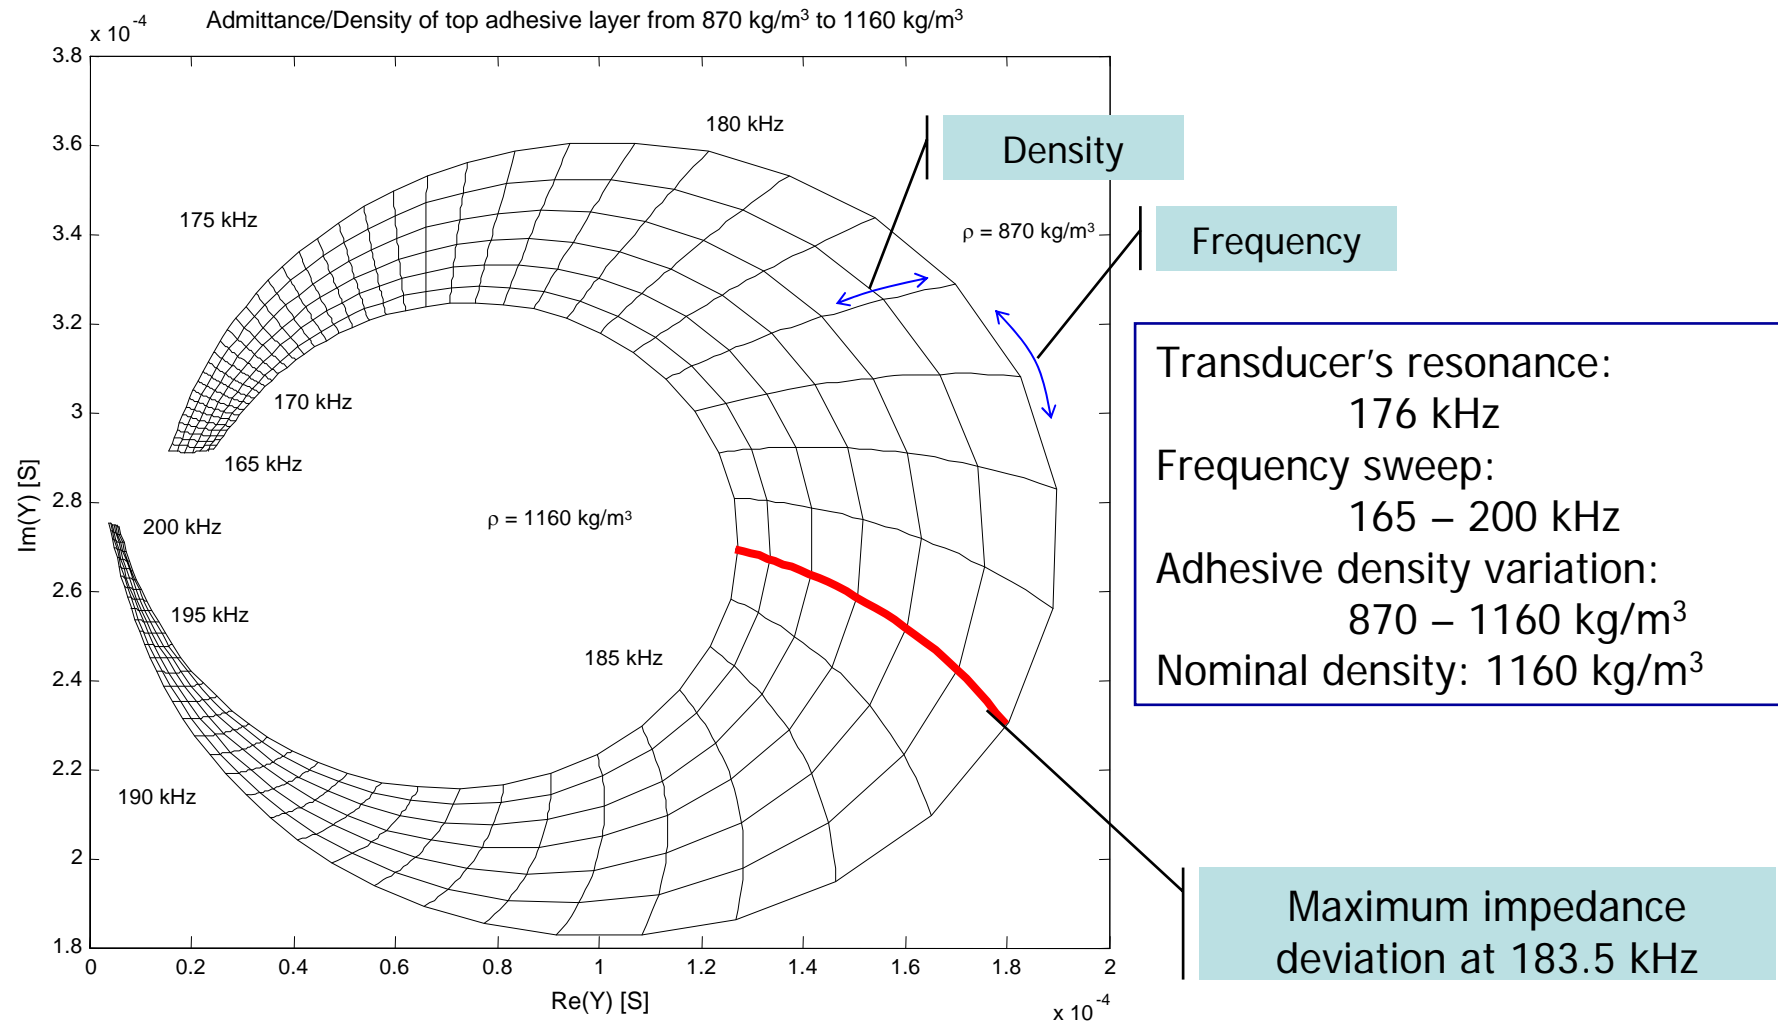
Electrical impedance on three-layered Al structure

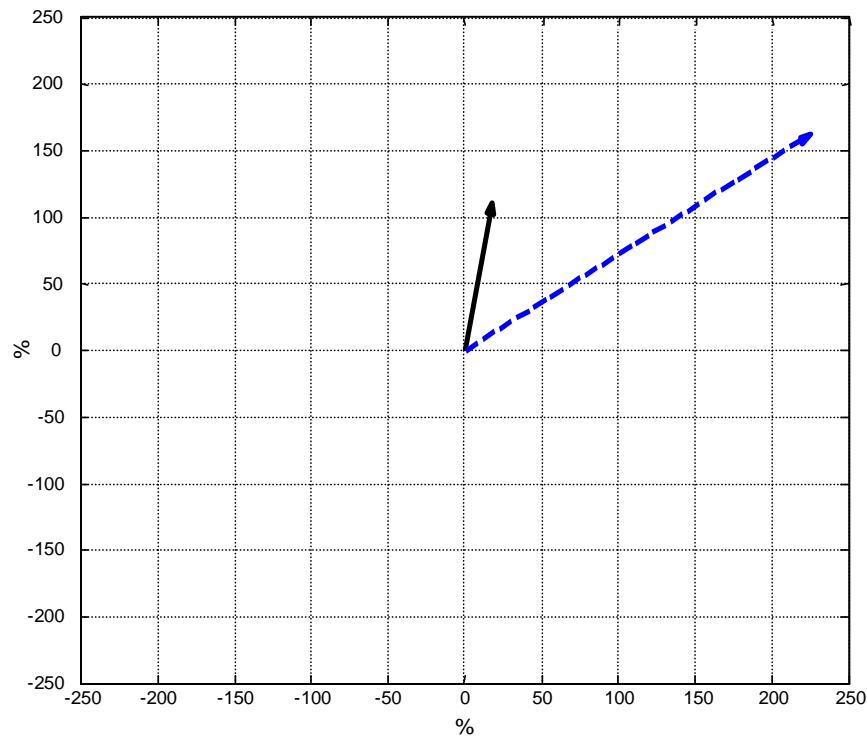
Single frequency plot at 176 kHz

Transducer's resonance at 176 kHz

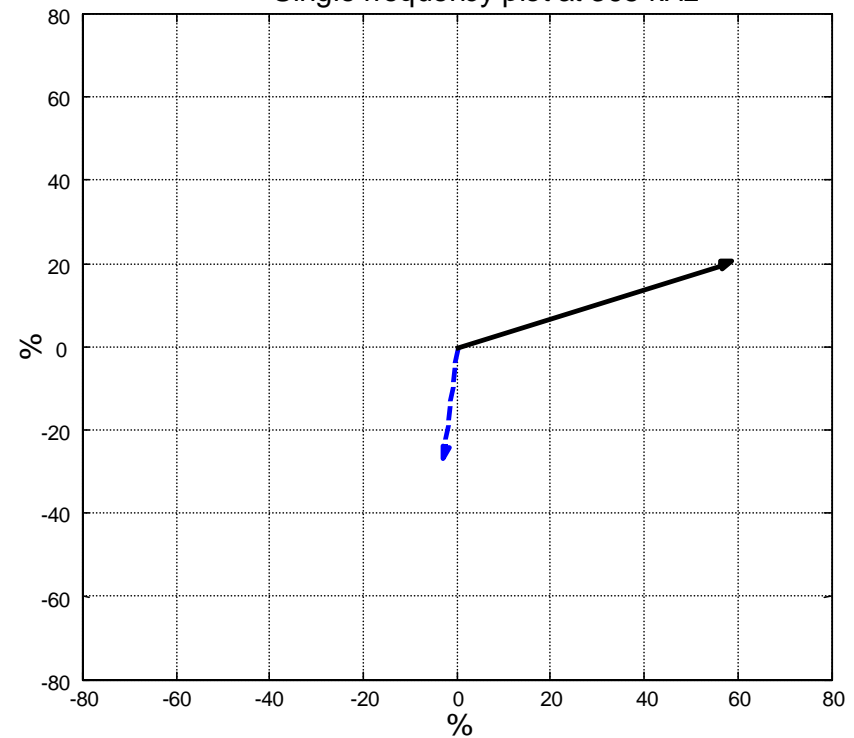
Single frequency plot at 395 kHz

Transducer's resonance at 439 kHz

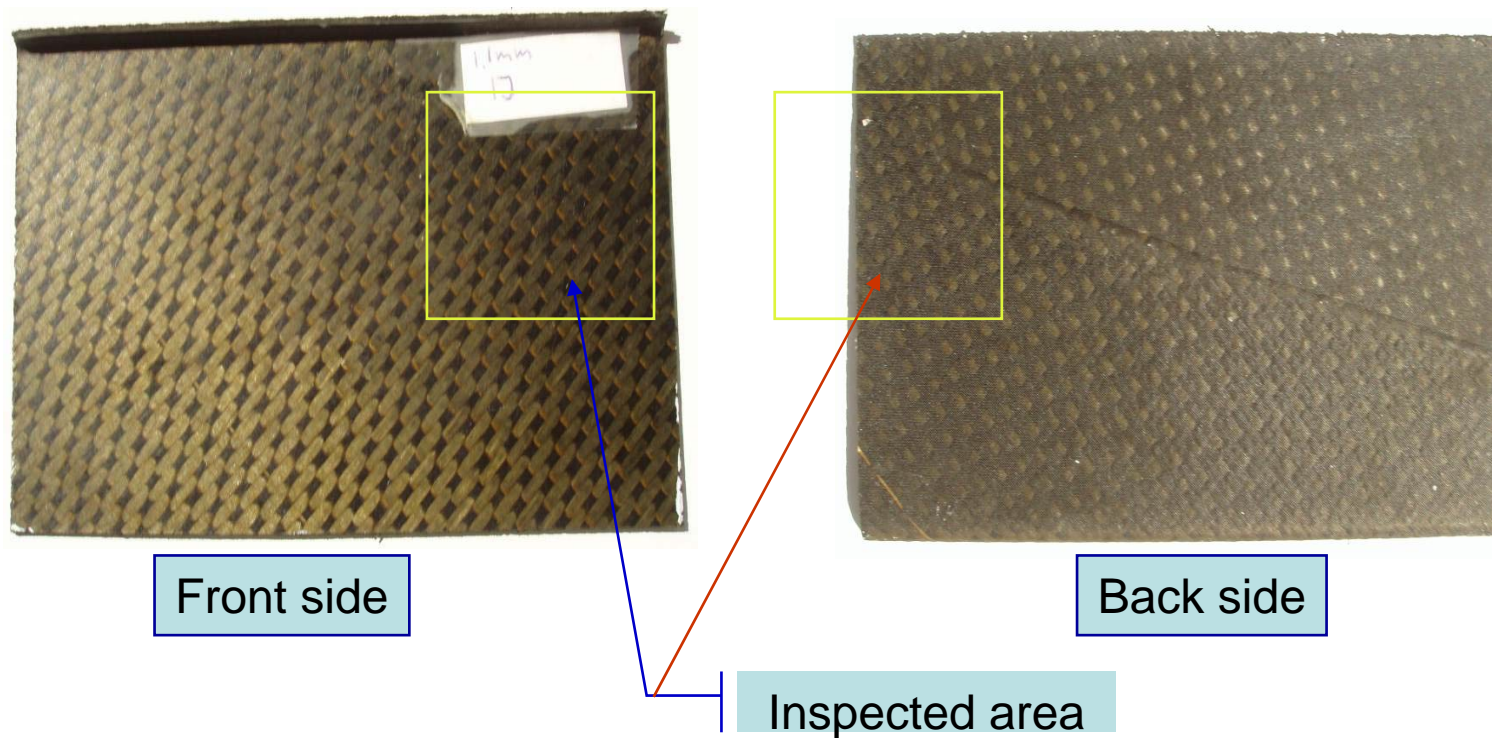
CFRP specimen with 1J impact

CFRP specimen with impact and local variation in thickness

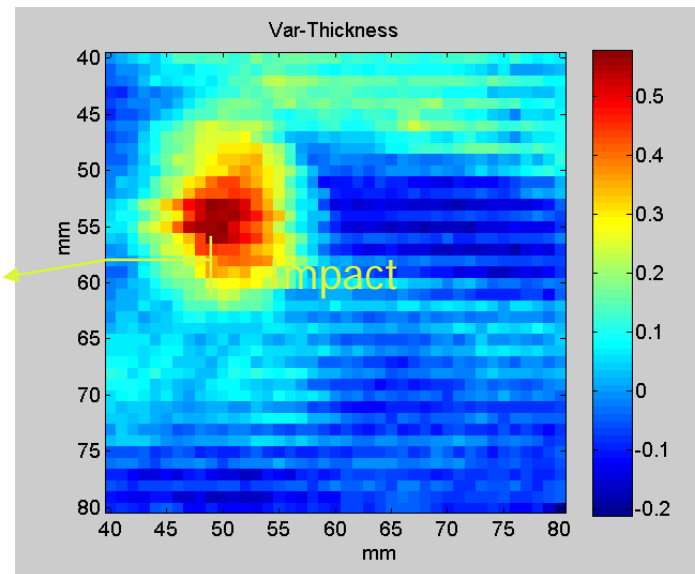
Transducer's frequency 1 MHz

Inspection of CFRP specimen with impact and local variation in thickness

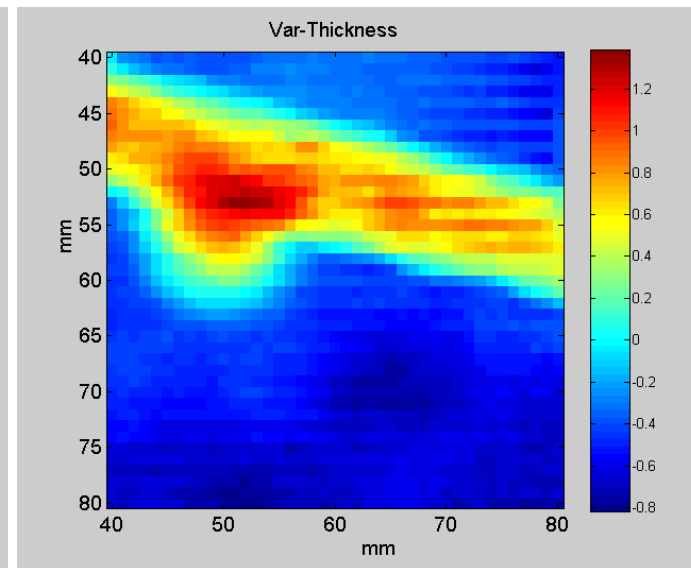
Transducer's frequency 2 MHz

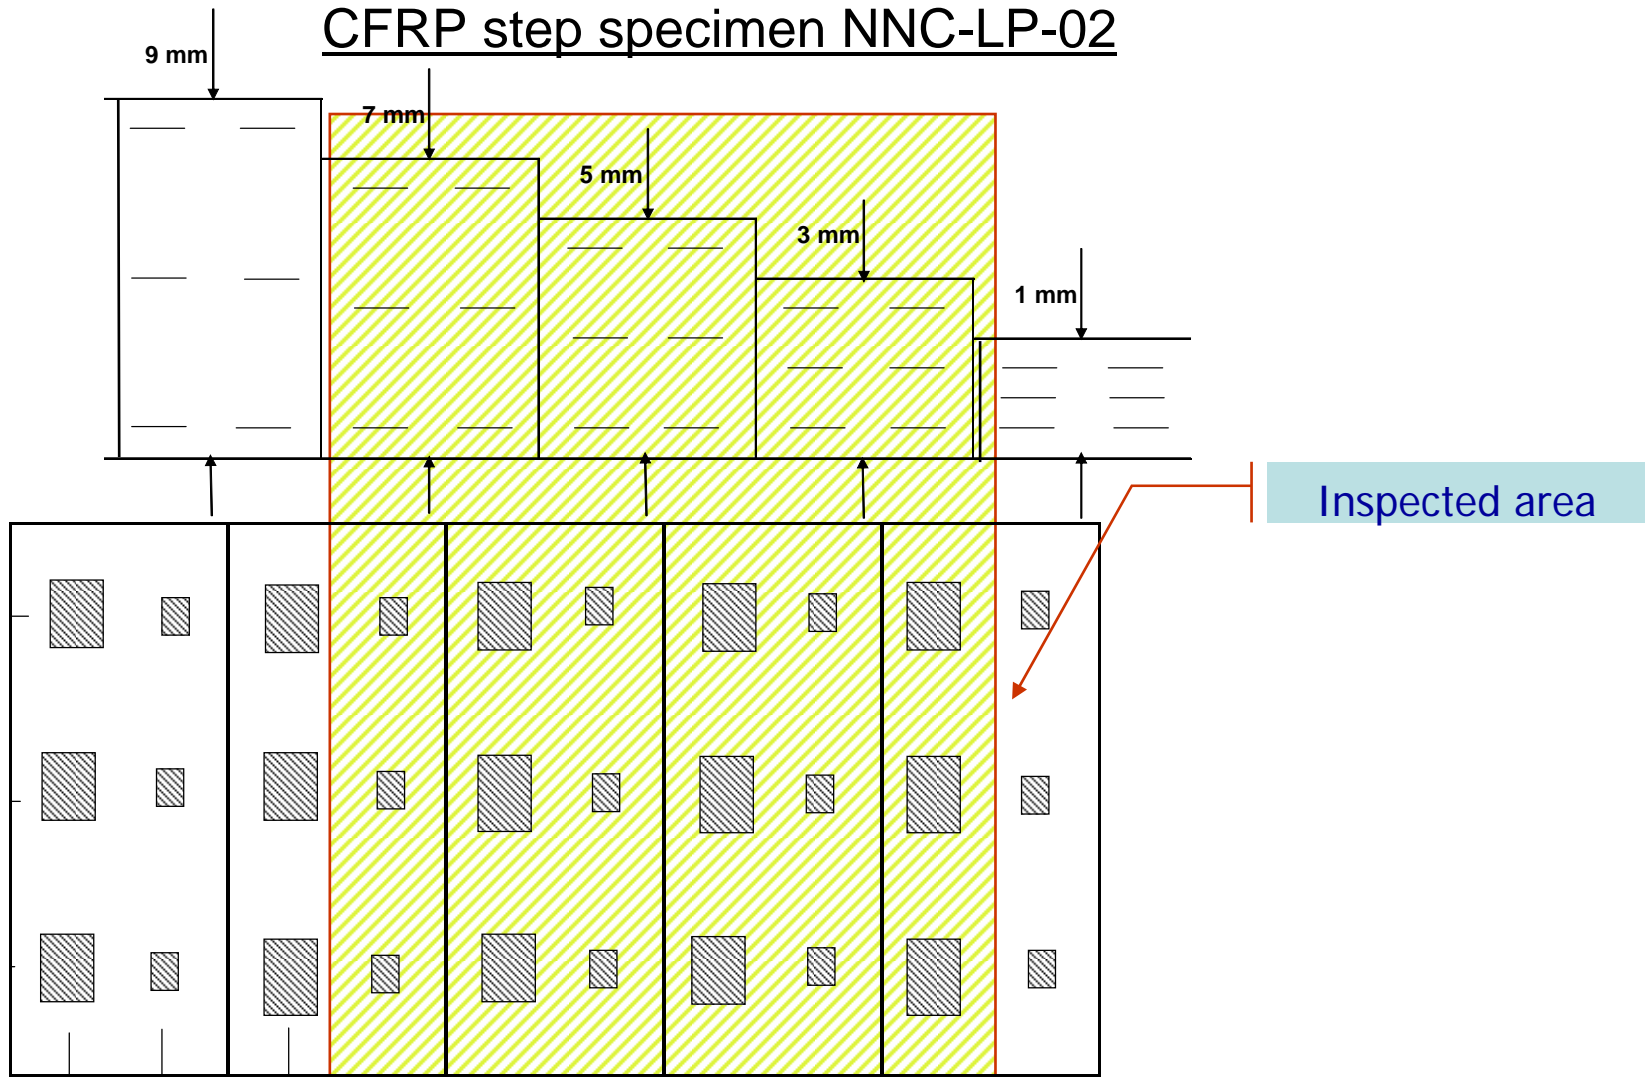
CFRP step specimen NNC-LP-02

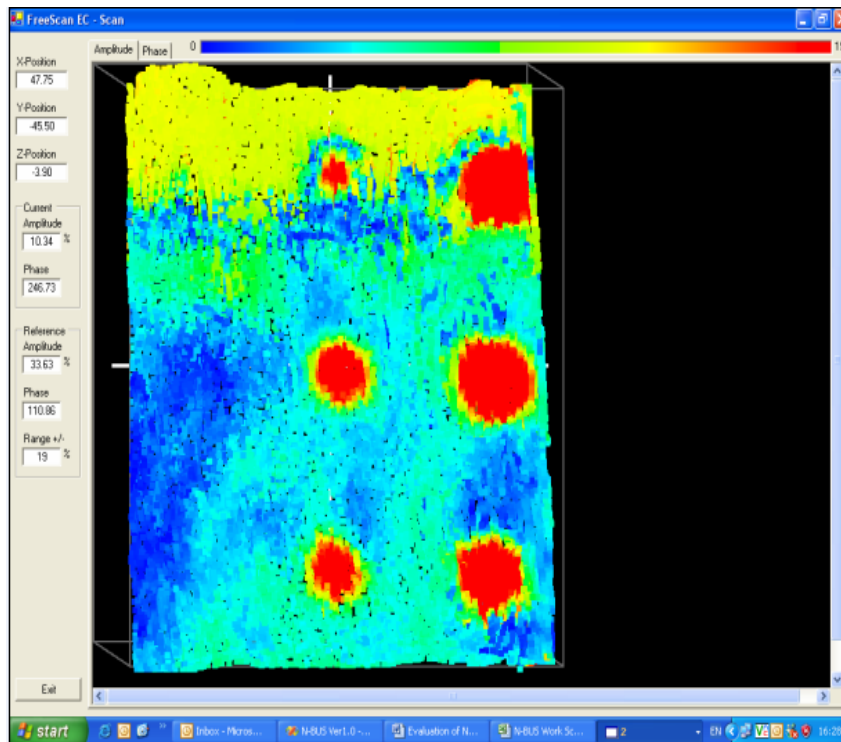
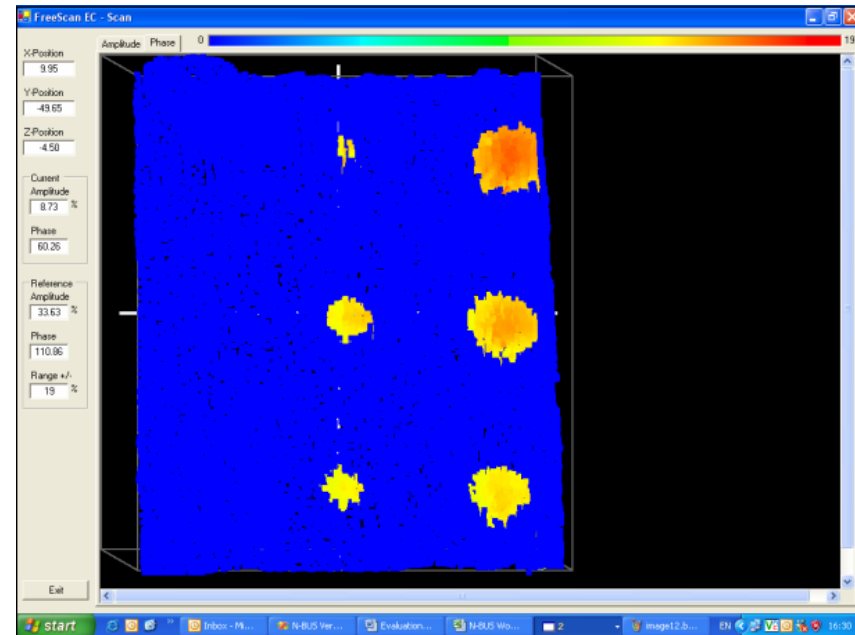
FreeScan N-BUS (CFRP)

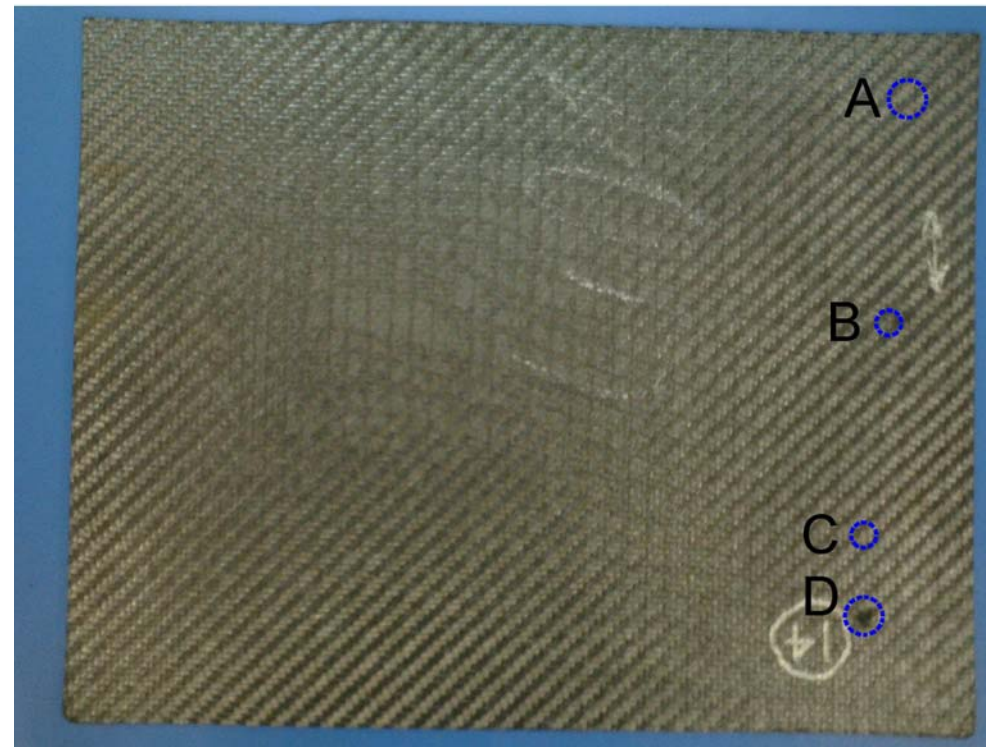
- Defects in 1.35 mm Thick Plate Sample

Thickness of the Sample: 1.35 mm

A. deep: 0.25 mm, diameter: 1 mm

B. deep: 0.23 mm, diameter: 4 mm

C. deep: 0.18 mm, diameter: 1 mm

D. deep: 0.38 mm, diameter: 7 mm

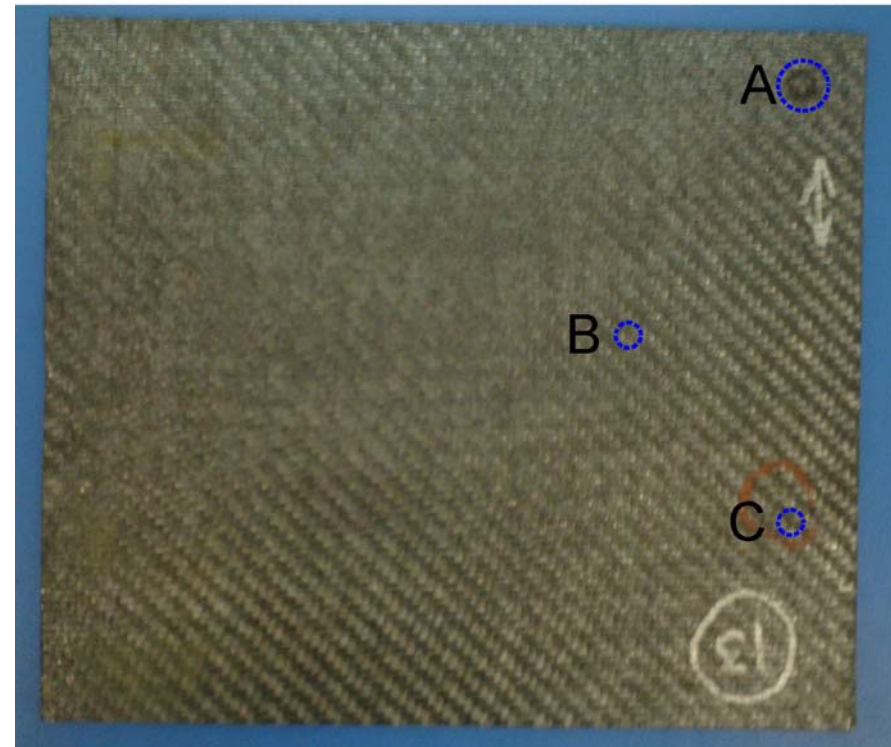
- Defects in 2.79 mm Thick Plate Sample

Thickness of the Sample: 2.79 mm

A. deep: 0.18 mm, diameter: 6 mm

B. deep: 0.29 mm, diameter: 2.6 mm

C. deep: 0.05 mm, diameter: 4 mm

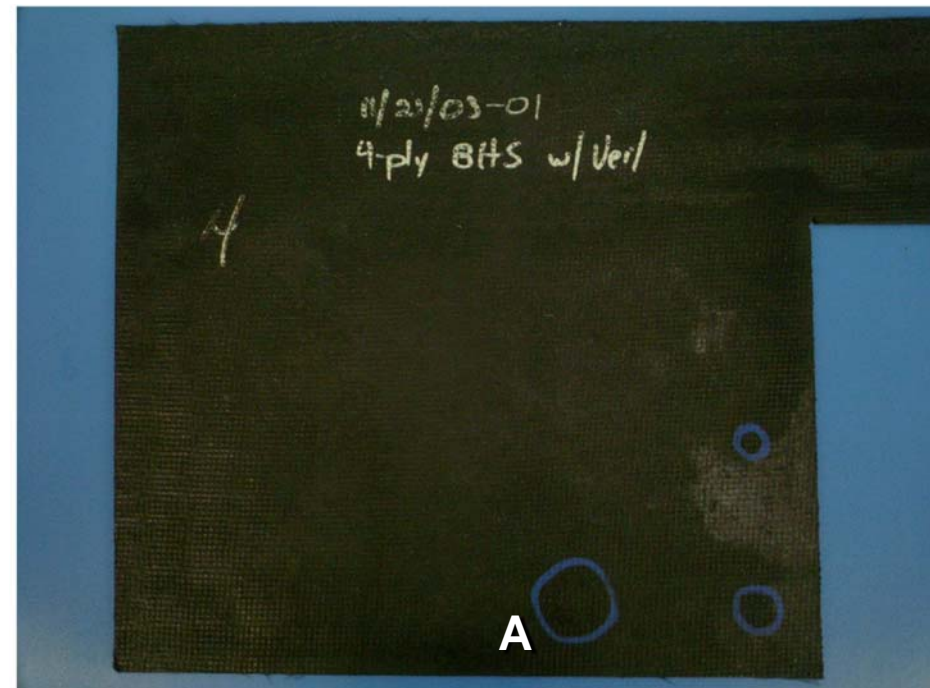
- Defects in 1.90 mm Thick Cut Sample

Thickness of the Sample: 1.90 mm

A. Deep: 0.25 mm, diameter: 20 mm

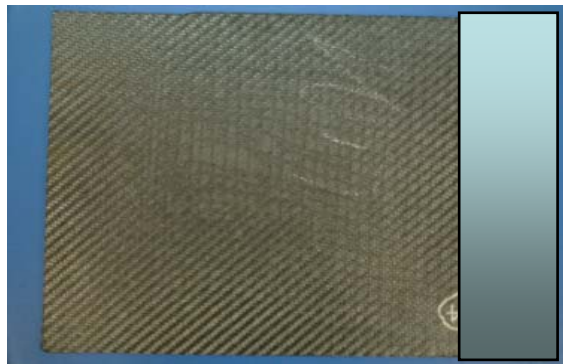
1 mm thick plate

- Due to restrictions in current C-Scan setup, the samples were scanned for 70 mm width at the right side as marked in the pictures above
- Scanning for N-BUS was also done over the same area for comparison purposes

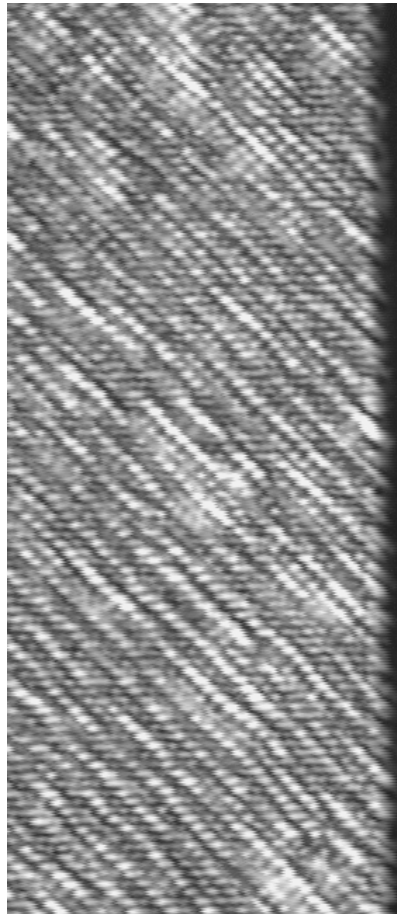
**C Scan Image
Pitch – catch
at 0.25 mm pitch**

- All the defects are picked up by Ultrasonic Immersion Through Transmission Technique
- Ultrasonic Immersion Pulse Echo Technique does not pick up most of the defects
- N-BUS technique along with FreeScan detects all the defects
- NBUS is the most suitable technique for deployment in following applications:
 - **In-service inspection of large components that cannot be taken into immersion tank**
 - **Inspection of components where access from both sides is not available.**

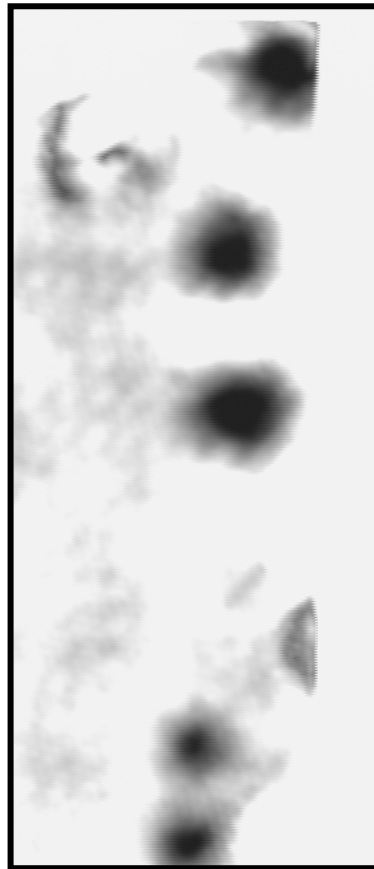
**C Scan Image
Through
Transmission
at 0.25 mm pitch**

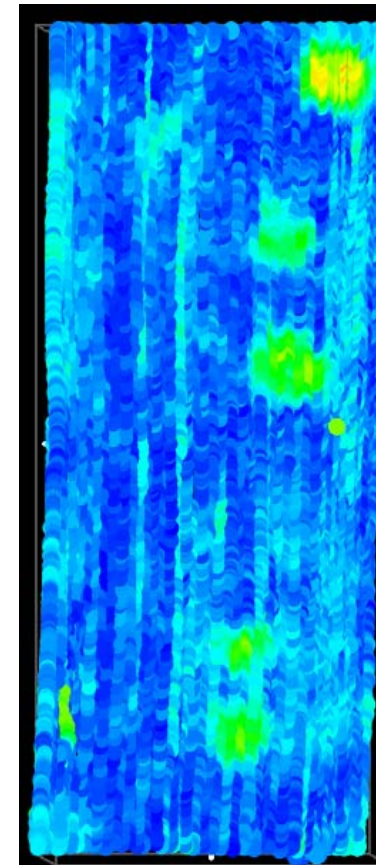
**N-BUS Scan
Image at 2 mm
pitch**

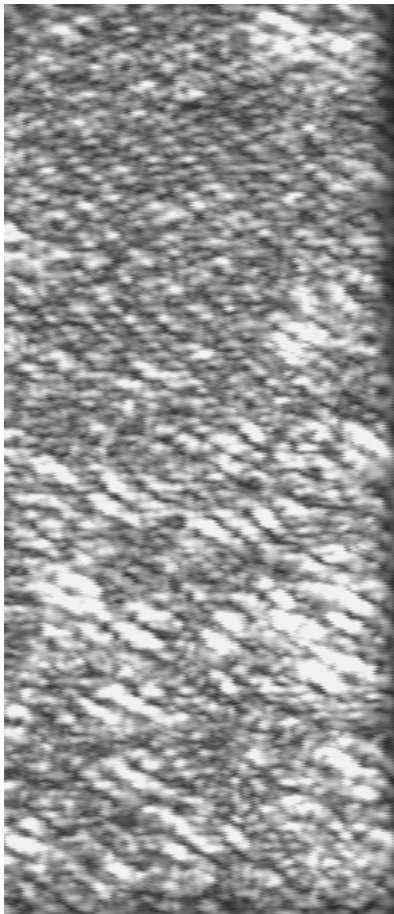
**C Scan Image
Pitch – catch
at 0.25 mm pitch**

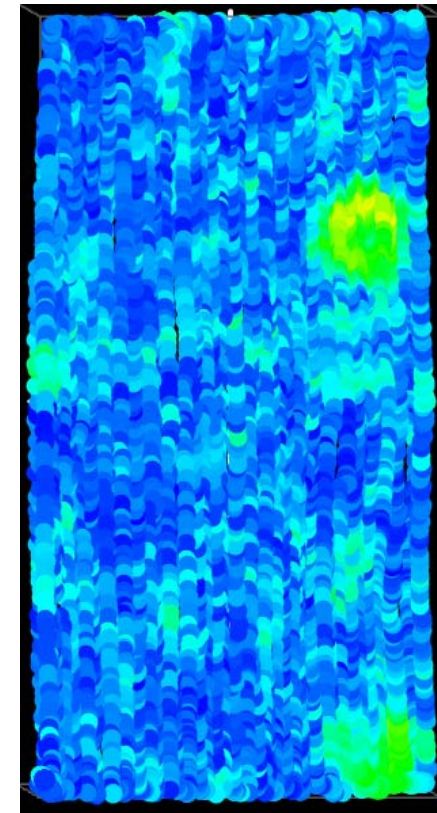
**N-BUS Scan
Image at 2 mm
pitch**

(defects on the
opposite side)

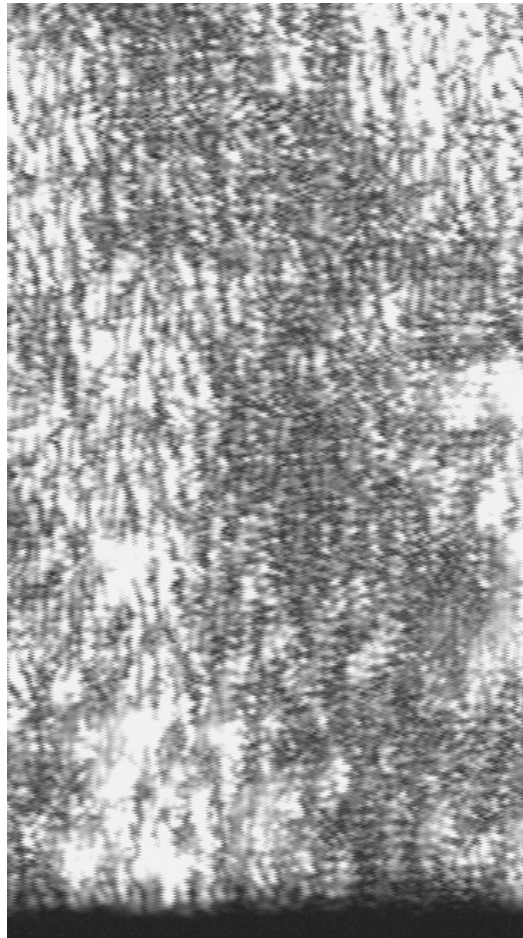
**C Scan Image Pitch – catch
at 0.25 mm pitch**

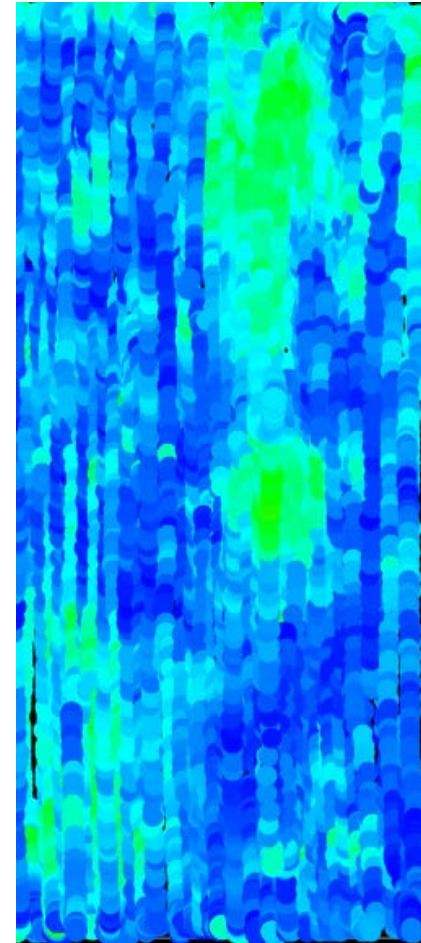
**N-BUS Scan Image at 2
mm pitch (scanned from
opposite side)**
